Building and Pest Inspection Report

Building Assessment Unit

19 Example STREET, Exemptown, VIC, 3000

Report/Agreement #	2603241243469
Inspection Date:	26 Mar 2024
Inspection Time:	12:43 pm

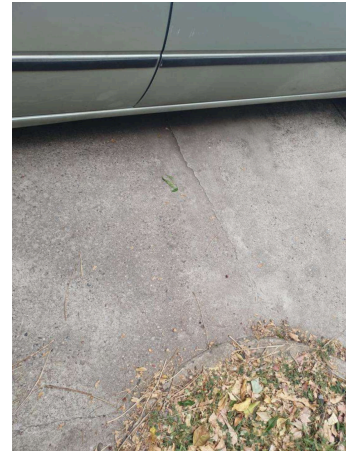
Driveway Condition

Common cracks were observed on the driveway. Whilst these cracks appeared to be typical at the time of inspection, we strongly recommend you monitor these cracks and if worsening occurs contact a concreter for further advice.

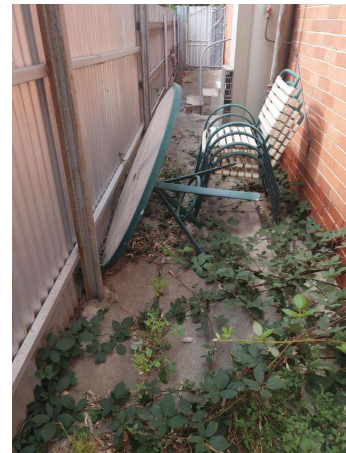
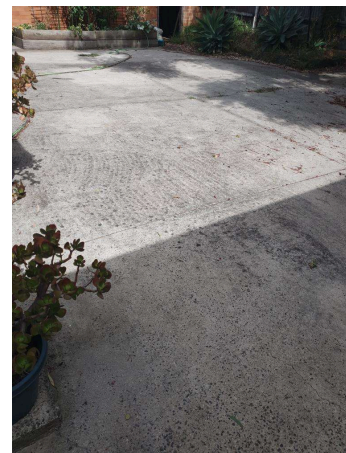
Pathways Condition

The concrete path is in poor condition replacement recommended. Contact a qualified concreter for repairs.

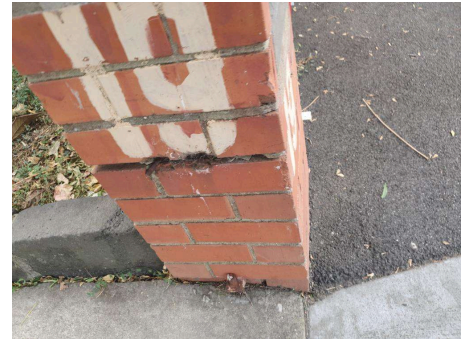
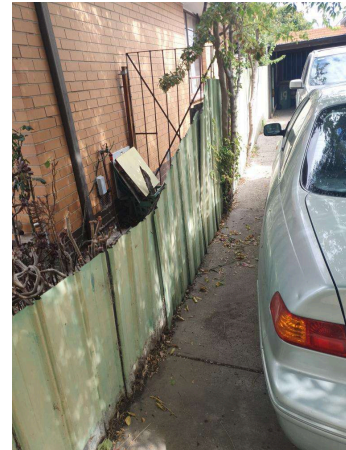
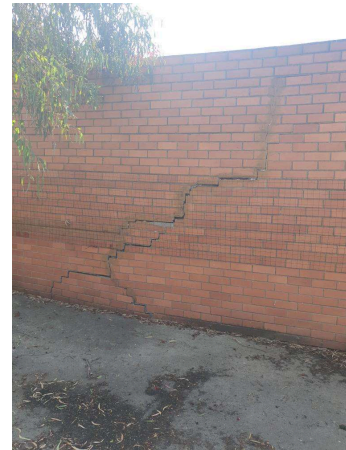
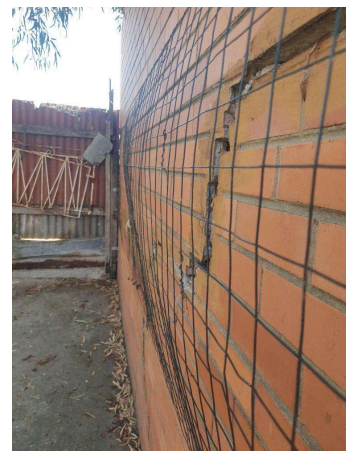
Overall Condition

The front brick fence has settlement/movement cracks. This may be a potential safety hazard. A qualified brick layer should be engaged for repairs. Damage was noted to the metal fence. Contact a fencing contractor for repairs. Some sections of the fence have general aging to the components. General upkeep and maintenance required and possible replacement of sections that cannot be repaired may be required. A qualified fencing contractor should be engaged for repairs. Sections of the fence components have rot. Repairs are required by fencing contractor. The front brick fence is leaning and is a hazard. Removal and replacement is required. We recommend that a fence builder is engaged to assess and rectify. The shared wall garage to the adjoining neighbours property had extensive structural cracking and is at risk of collapse. This is a hazard and major structural defect which may affect the health and safety of the occupants and propping of the garage wall is urgently required. We recommend that a structural engineer is engaged to assess and provide further recommendations.

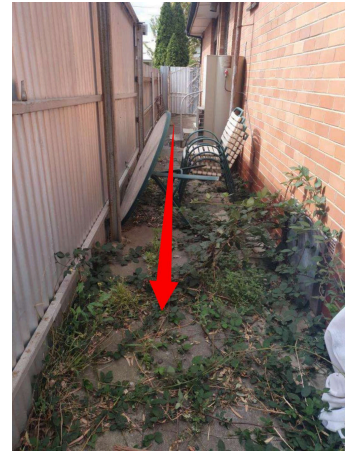
Surface Drainage
Drainage Findings

The ground levels along the perimeter walls at the front of the home did not appear to fall away from the property walls sufficiently due to the natural landscape and contour. This will need to be assessed during a period of rainfall and if surface water appears to be entering the sub floor if applicable or ponding against the perimeter walls, engage a plumber or landscaper to assess and rectify as required. All drains should be regularly checked by a plumber and kept clean of debris to allow surface water to be carried away from the dwelling.

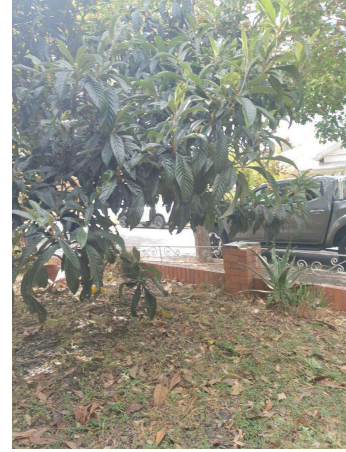
Trees are close to dwelling. There is visible wall cracking in the vicinity. Engage a a Structural Engineer and qualified arborist to carry out an assessment on potential issues.

A large tree is present close to the home with roots systems that may impact the home. We recommend that an arborist is engaged to assess and provide further recommendations.

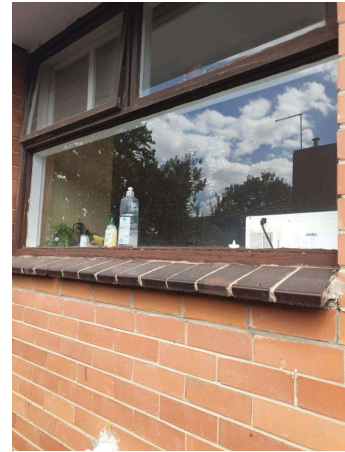
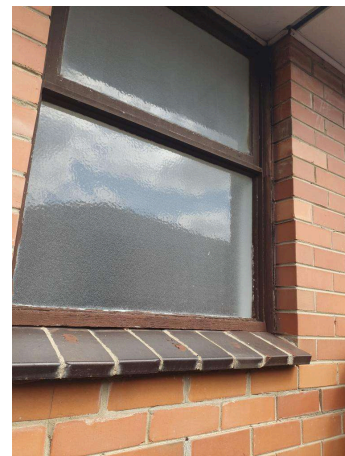
Overall Condition

General age/damage has occurred to window components.

This can be due to wall movement or footings settlement. A structural engineer should be engaged for advice and recommendations.

Restoration work recommended. A qualified carpenter should be engaged for advice and recommendations.

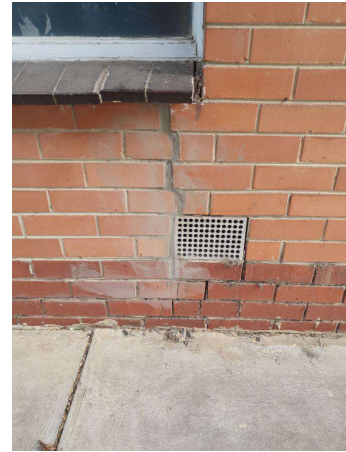
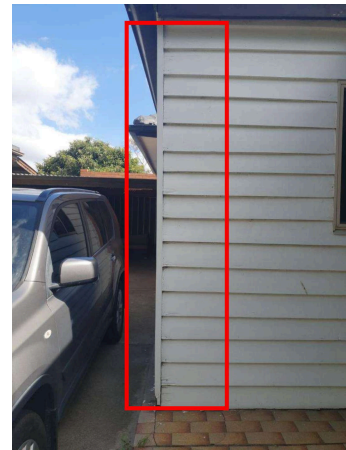
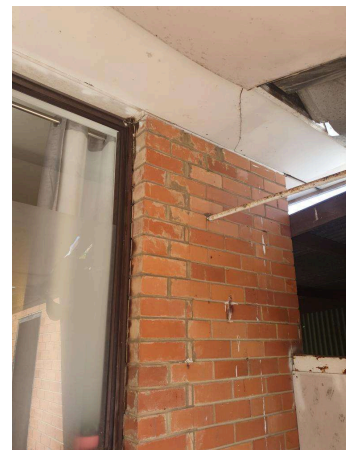
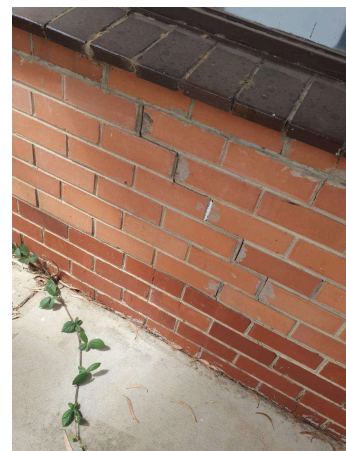
Condition

There appears to have been some settlement in the building which has caused some cracking to the walls. These cracks are categorized as 0 to 2. This can also cause some doors to bind or be out of square. In the inspectors opinion these cracks are due to settlement, usually due to ground movement and subsequent movement to building materials can be expected. Any cracks should be monitored and if cracks increase in size, further investigation should be carried out by a structural engineer.

For clarification on the category of cracks please refer to Cracking of Building Elements in Section 2D of the Terms and Conditions contained in this report.
Cracks noted (Damage Category 3 to 4)

For clarification on the category of cracks with a damage category of 3 to 4, please refer to Cracking of Building Elements in Section 2D of the Terms and Conditions of this report.
 Minor decay was noted to the external wall lining. We recommend replacement of all affected timbers. Sections of the cladding where the weatherboard meets the end stop have gaps which may allow water ingress to occur. We recommend that a caulking contractor is engaged to assess and seal.

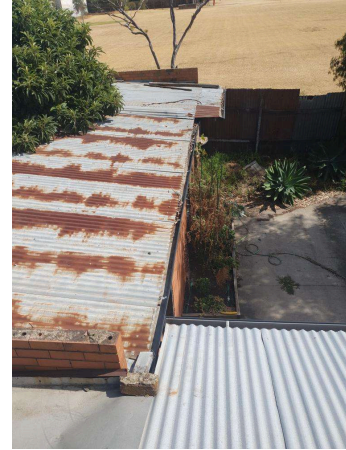
Rust on roof sheeting. A qualified roofing plumber should be engaged for repairs. Sheet fixings lifted. A qualified roofer should be engaged for immediate repairs due to water ingress into the roof cavity.

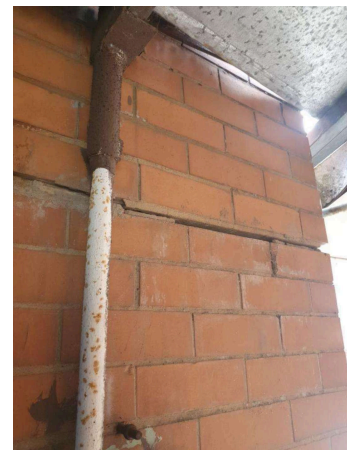
Wall Cladding Findings

Cracks noted. Possible causes may be foundation movement. Support structure deflection. Thermal movement and moisture uptake or loss, failure under external loads. A structural engineer should be consulted for further evaluation and advice.

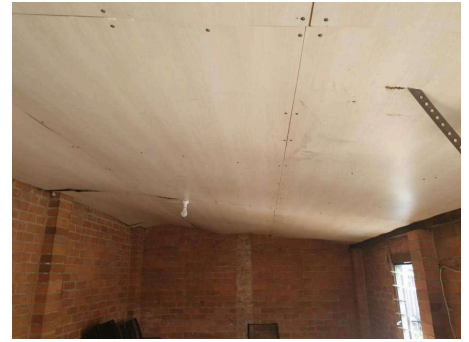
Ceiling Findings

Ceiling sagging - Requires repair from a safety perspective. I recommend you contact a qualified plasterer for further advice and recommendations.

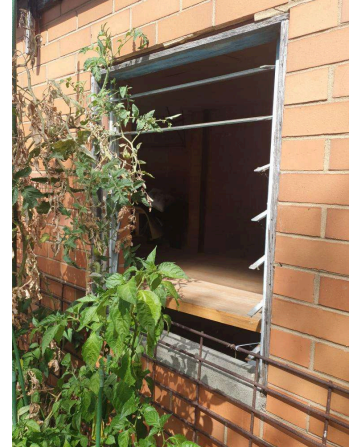
Window Findings

Louver window pane missing - Recommendations: A qualified glazier contractor should be engaged for advice and recommendations.

Timber fungal decay and water damage on window frames. A qualified carpenter should be engaged for to assess and rectify.

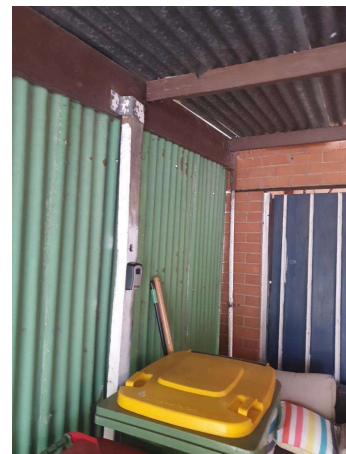
Overall Condition

The carport is in poor condition and replacement is required. We recommend that a carport builder is engaged to assess and rectify.

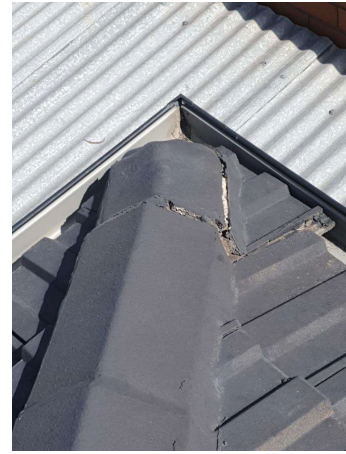
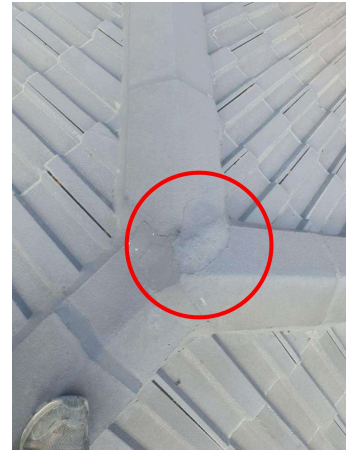
A hip cap has slipped and rectification is required. We recommend that a roof tiler is engaged to assess and rectify.

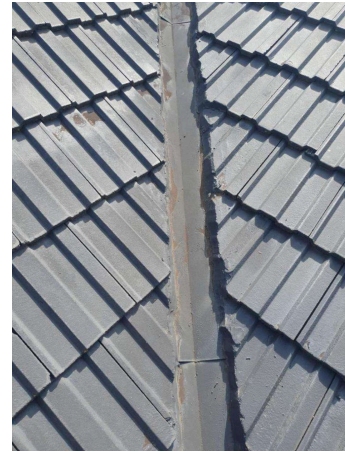
Flashing Conditions

Flashing fixings lifted or not sufficiently installed may allow water ingress to occur into the roof cavity. A qualified roof plumber should be engaged for repairs and recommendations. Gaps are present to some flashings and may allow for water ingress into the property. We recommend that a roof plumber is engaged to assess and rectify. The valleys are corroded and replacement is required. We recommend that a roof plumber is engaged to assess and rectify. There is an inadequate clearance to the soaker between the flashing and tiles, which may allow for debris to collect and water ingress to occur. We recommend that a roof plumber is engaged to assess and rectify.

Gap to flashing allowing water ingress

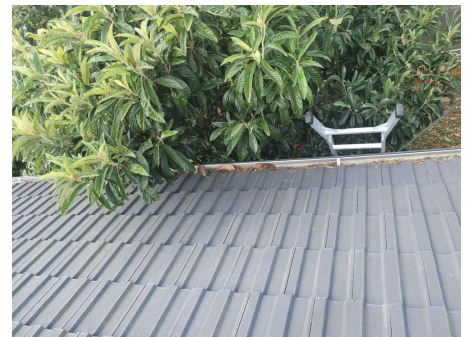
Debris in guttering areas- this requires cleaning out to prevent blocking of downpipes and leaking into eaves and fascia. Have gutters cleaned and assessed by a plumber for adequate fall. Regularly clean to prevent ponding. Ponding water will contribute to rust.

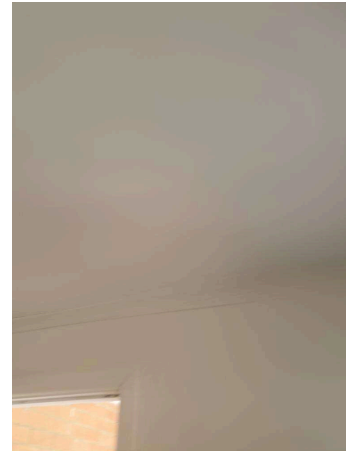
Ceiling stains - No moisture readings obtained. These may have been repaired however you will need to monitor after a prolonged period of rainfall. If leaking persists, a qualified plumber should be engaged for advice and recommendations. All water damaged plaster should be replaced.

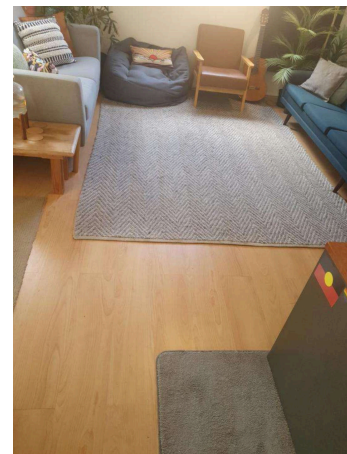
Flooring

Unevenness or unlevel sections visible in floor. Possibly due to poor workmanship or excessive movement/settlement. We recommend that a structural engineer is engaged to access and provide further recommendations.

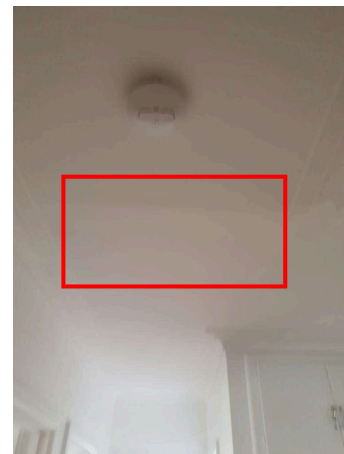
Ceiling

Settlement Cracks Noted. These are typical and generally patch and paint will suffice, however monitoring these cracks is advised for 12 months and if they become worse, further investigation by a suitably qualified professional is advised.

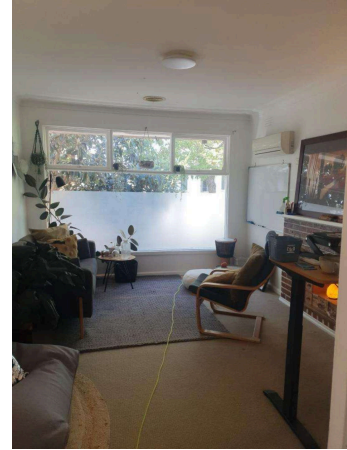
Flooring

Unevenness or unlevel sections visible in floor. Possibly due to poor workmanship or excessive movement/settlement. We recommend that a structural engineer is engaged to access and provide further recommendations.

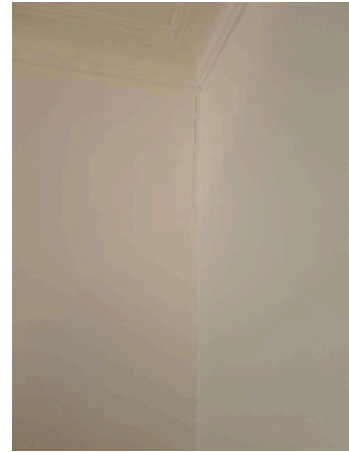
Nail popping observed to the ceiling lining. This is should be repaired as soon as possible by a qualified plasterer to avoid any unsafe conditions. Ceiling sagging - Requires immediate repairs to prevent further collapse. Contact a qualified plasterer for repairs.

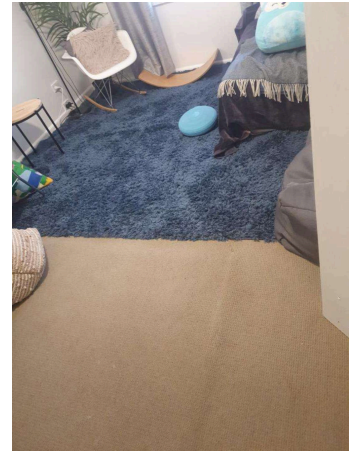
Flooring

Unevenness visible in floor which is generally caused due to by excessive movement/settlement. We recommend that a structural engineer is engaged to assess and rectify.

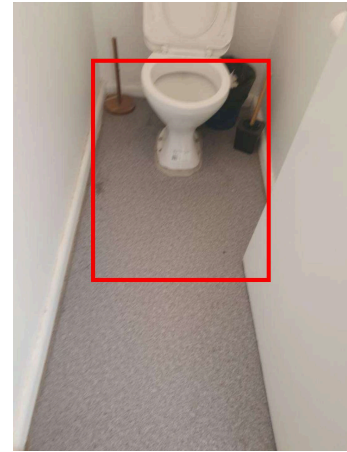
Flooring

Unevenness or unlevel sections visible in floor. Possibly due to poor workmanship or excessive movement/settlement. We recommend that a structural engineer is engaged to access and provide further recommendations.

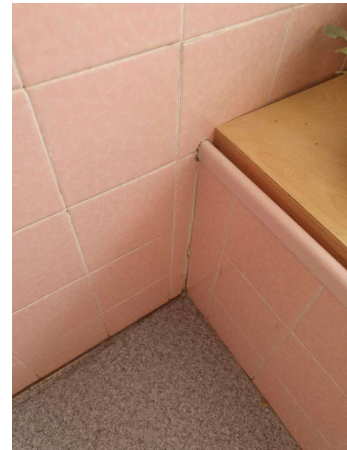
Settlement Cracks Noted . These are typical and generally patch and paint will suffice, however Monitoring these cracks advised for 12 months and if become wider or longer, you will need to contact a structural engineers to assess.

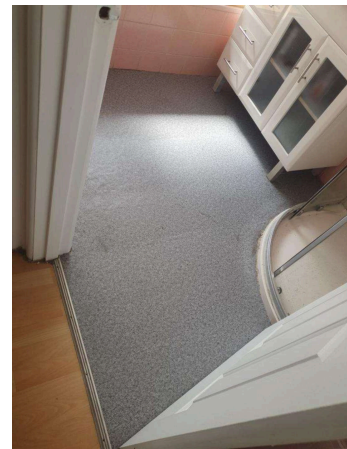
Flooring

Unevenness or unlevel sections visible in floor. Possibly due to poor workmanship or excessive movement/settlement. We recommend that a structural engineer is engaged to access and provide further recommendations.

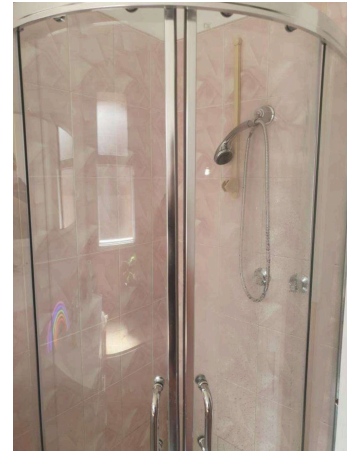
Shower And Bath

Large gaps were present to the shower screen and maintenance or replacement is required. We recommend that a shower screen contractor is engaged to assess and rectify.

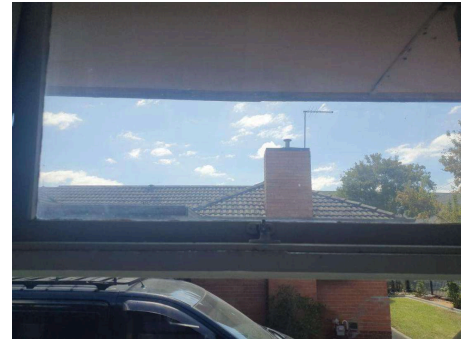
Windows

Binding window/s - This can relate to some differential settlement in the footings, frame movement, age and the like. It can also be seasonal where the windows may bind for some months and then open and close sufficiently. Recommendations: If binding is persistent, a qualified carpenter should be engaged for advice and recommendations.

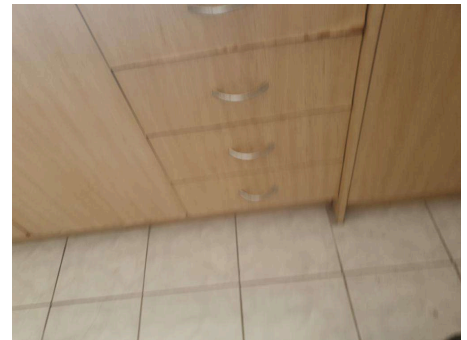
Cupboards And Bench Tops

Water damage to cabinet observed. Replacement required. Contact a cabinet maker for repairs.

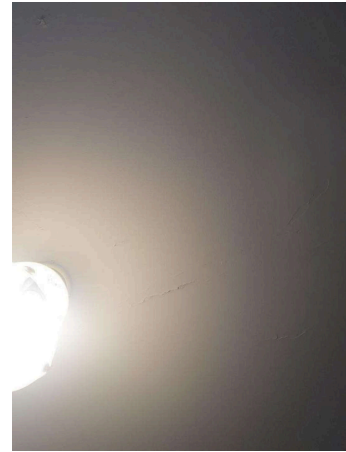
Ceiling paint flake/deterioration is evident. Recommendations: General maintenance / painting as required.

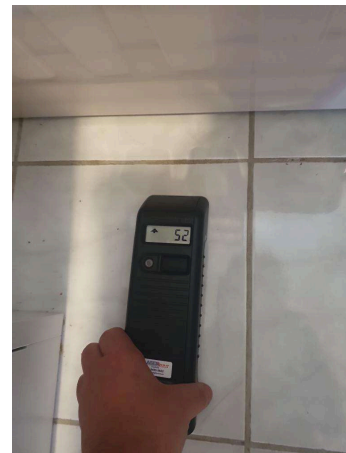
Floor

Cracked floor tiles - Recommendations: A qualified tiler should be engaged for advice and recommendations. This needs to be repaired at the earliest as this has the potential to lead to many related issues such as damp, water ingress to other areas. Unevenness visible in floor which is generally caused due to by excessive movement/settlement. We recommend that a structural engineer is engaged to assess and rectify.

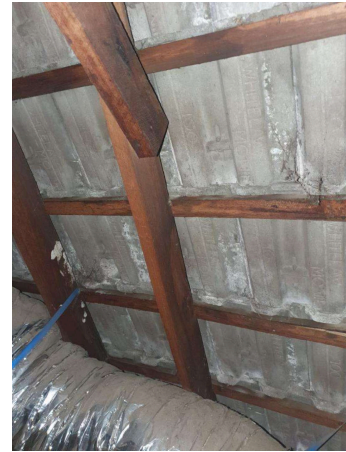
Roof Cladding

Efflorescence observed indicating water absorption. White stains on tile roofs are typically an efflorescence deposit and may indicate that the tile is absorbing water, thus nearing end of life. A qualified roof restorer/tiler should be engaged for advice and recommendations.
