Building and Pest Inspection Report

Building Assessment Unit

19 Example STREET, Exemptown, VIC, 3000

Report/Agreement #	2603241243469
Inspection Date:	26 Mar 2024
Inspection Time:	12:43 pm

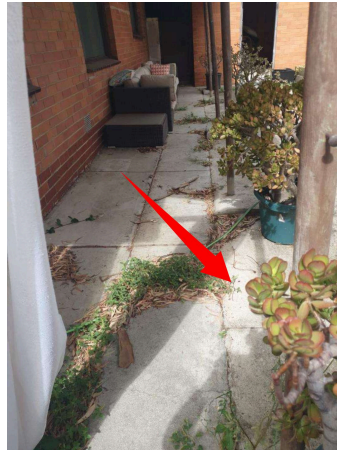
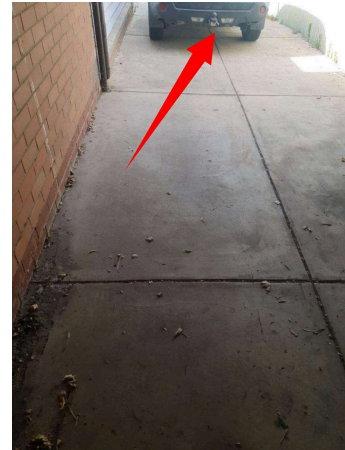
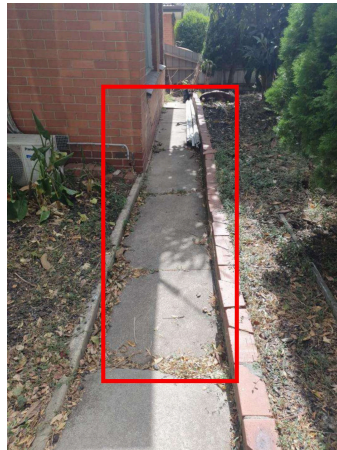
Drains

Poor drainage and/or areas where water is ponding around the perimeter of the home was identified. We recommend that addition drainage is installed to the perimeter of the home to mitigate water ingress into the subfloor area. A plumber should be engaged to assess and rectify.

We recommend that all external paths, and soil is graded away from the dwelling.

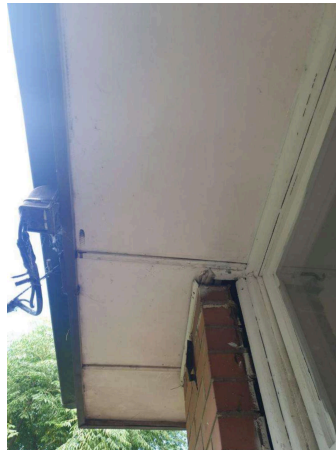
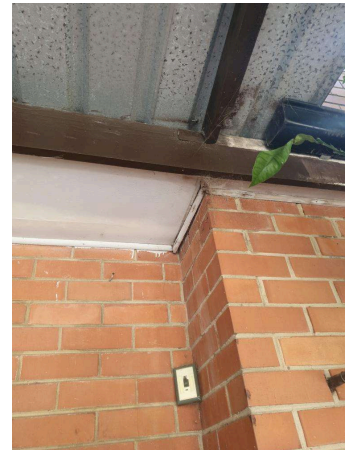
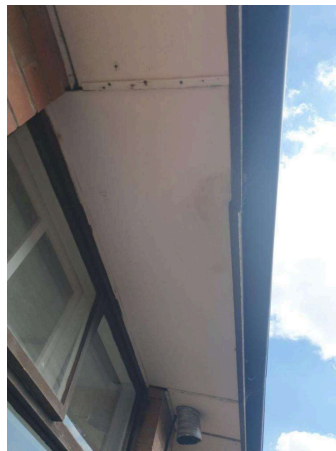
Eave Condition

Fibrous Cement Sheeting cladding sections. We recommend an ASBESTOS Inspection be conducted by a licensed Asbestos Inspector prior to a decision to purchase. Considered a Safety Hazard
 Eave lining stains observed. Normally this occurs due to overflow in blocked gutters. Recommendations. Gutters should be kept clear of debris and eave linings can then be painted or repaired as required.
 Quad deteriorated or detached in areas and repair/replacement is required. We recommend that a carpenter is engaged to assess and rectify.

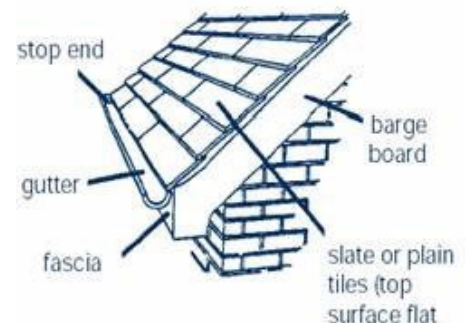
Condition

On visual inspection, the general condition of the fascia/barge boards is serviceable.

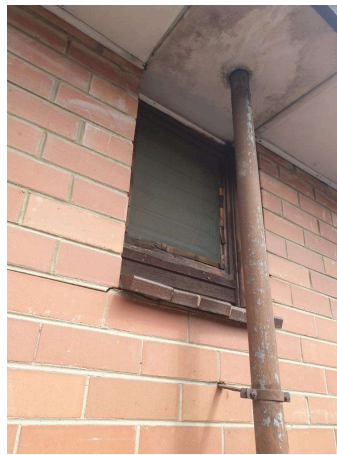
Gaps between window frame and wall cladding evident -

This can be due to wall movement or footings settlement. A structural engineer should be engaged for advice and recommendations.

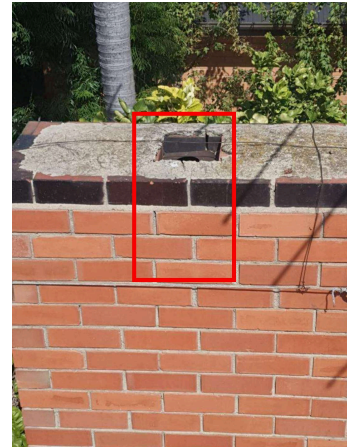
Condition

The cowl yo the top appears to be missing however access is unavailable to this area due to the height. Missing cowl may allow water ingress into the property. We recommend that a chimney specialist is engaged to assess and rectify.

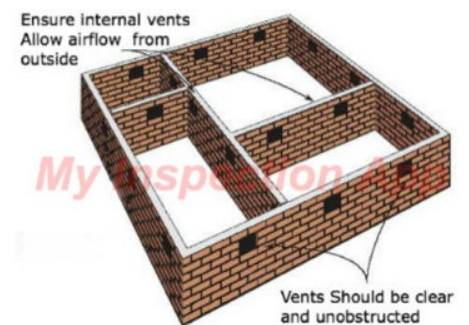
Findings

The vents are unobstructed.

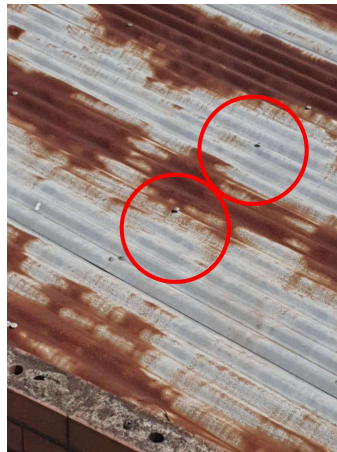
Roof And Gutter

Rust on roof sheeting. A qualified roofing plumber should be engaged for repairs. Sheet fixings lifted. A qualified roofer should be engaged for immediate repairs due to water ingress into the roof cavity.

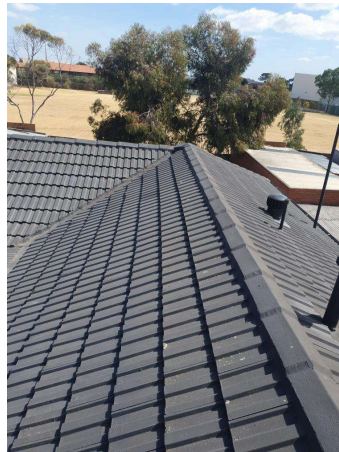
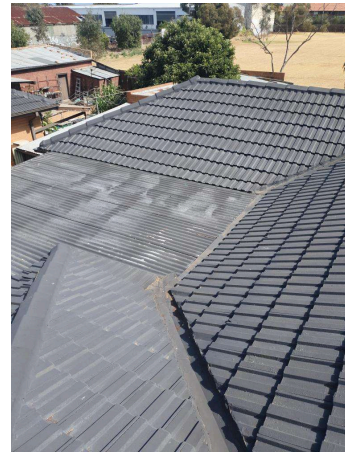
Overall Condition

On inspection, defects were noted that may require further assessment and recommendations by licensed roofer.

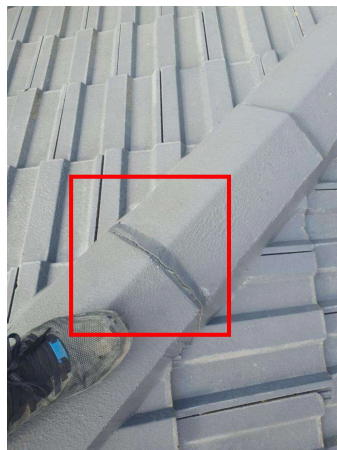
Roof Clad Condition

Minor cracking to the bedding mortar and pointing was identified and maintenance of these areas is required. We recommend that a roof tiler is engaged to assess and rectify. The roof sheets are not adequately sloped to direct water toward the box gutter, exhibiting negative fall in certain areas.

A hip cap has slipped and rectification is required. We recommend that a roof tiler is engaged to assess and rectify.

It is advisable to engage the services of a qualified roof plumber to evaluate the situation and implement the necessary corrective measures.

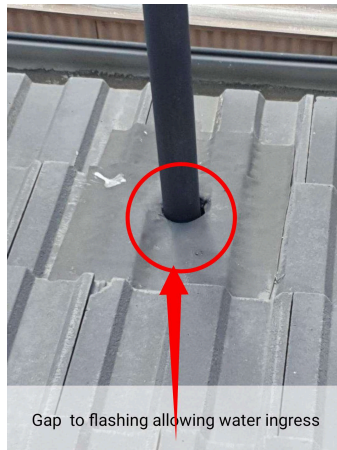
Flashing Conditions

Flashing fixings lifted or not sufficiently installed may allow water ingress to occur into the roof cavity. A qualified roof plumber should be engaged for repairs and recommendations. Gaps are present to some flashings and may allow for water ingress into the property. We recommend that a roof plumber is engaged to assess and rectify. The valleys are corroded and replacement is required. We recommend that a roof plumber is engaged to assess and rectify. There is an inadequate clearance to the soaker between the flashing and tiles, which may allow for debris to collect and water ingress to occur. We recommend that a roof plumber is engaged to assess and rectify.

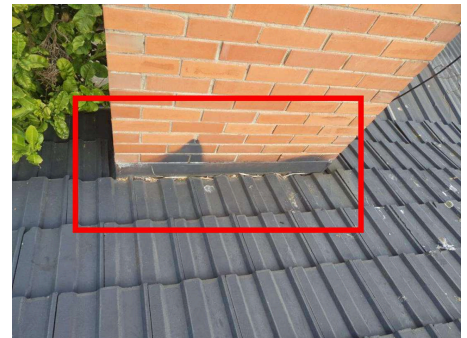
Gap to flashing allowing water ingress

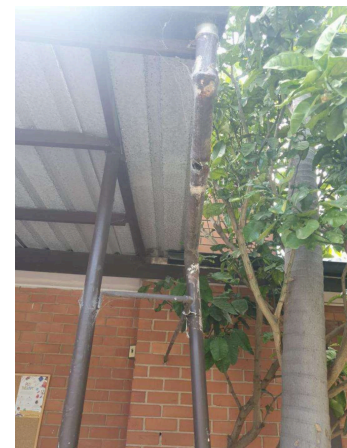
Downpipe Findings

Downpipe/s not connected to storm water discharge - Downpipes not connected to storm water have the potential to cause differential settlement to the footings, cause rising damp and is also conducive to termite infestation. A qualified roof plumber should be engaged for advice and recommendations. Rust penetrations observed to downpipe. Over time this has potential to cause differential settlement to the footings, cause rising damp and is also conducive to termite infestation. A qualified plumber should be engaged for advice and recommendations.

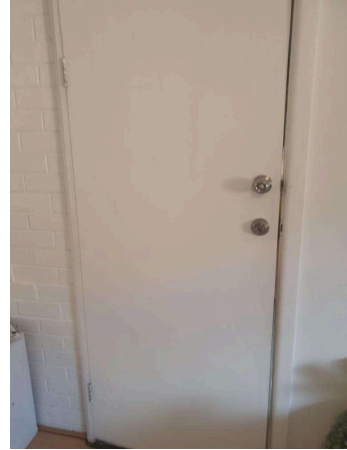
Front Entry Doors

The doors are in serviceable condition with no notable defects observed.

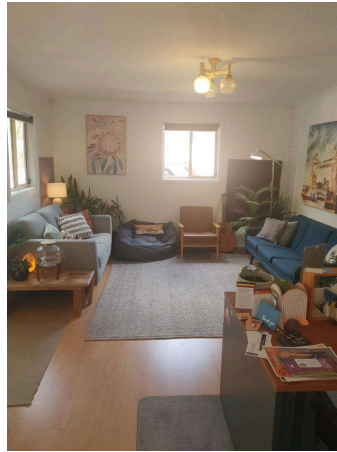
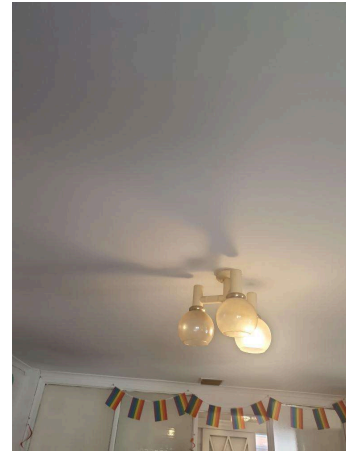
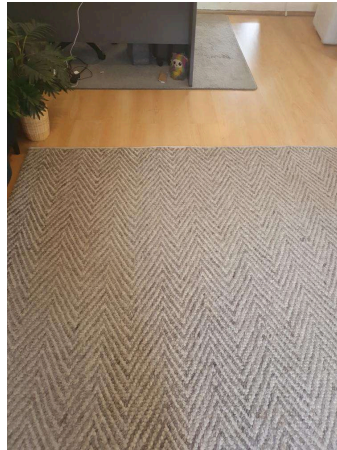
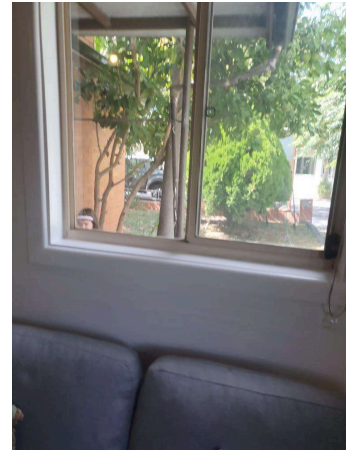
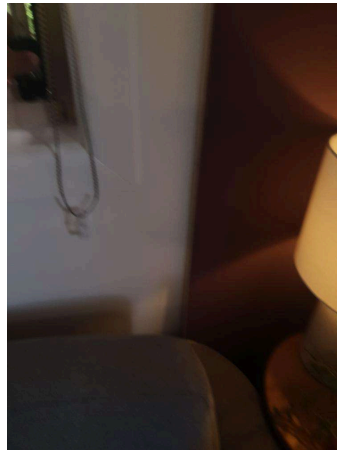
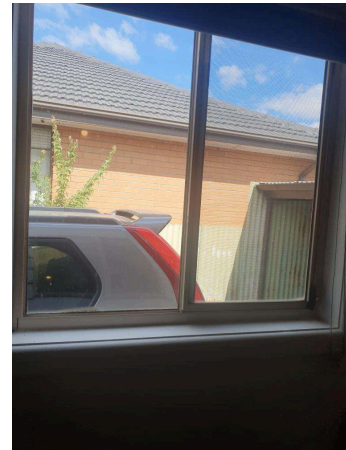
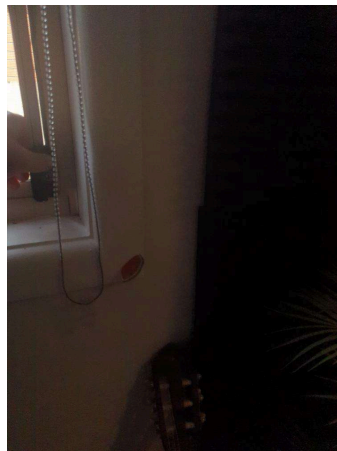
Ceiling stains - No moisture readings obtained. These may have been repaired however you will need to monitor after a prolonged period of rainfall. If leaking persists, a qualified plumber should be engaged for advice and recommendations. All water damaged plaster should be replaced.

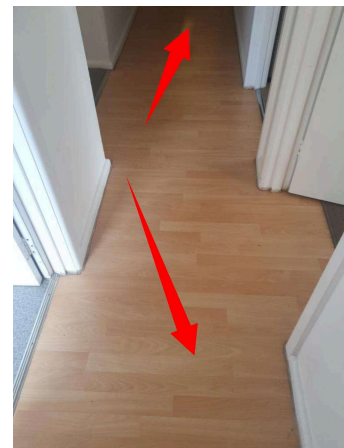
Flooring

Unevenness or unlevel sections visible in floor. Possibly due to poor workmanship or excessive movement/settlement. We recommend that a structural engineer is engaged to access and provide further recommendations.

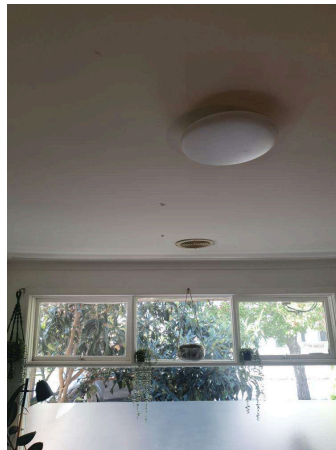
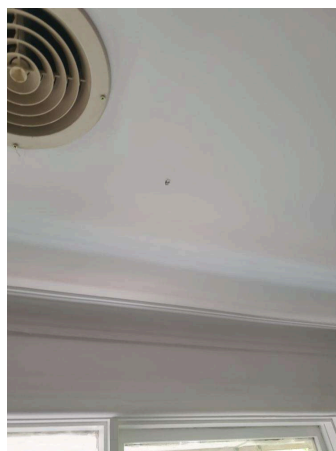
Nail popping observed to the ceiling lining. This is should be repaired as soon as possible by a qualified plasterer to avoid any unsafe conditions. Ceiling sagging - Requires immediate repairs to prevent further collapse. Contact a qualified plasterer for repairs.

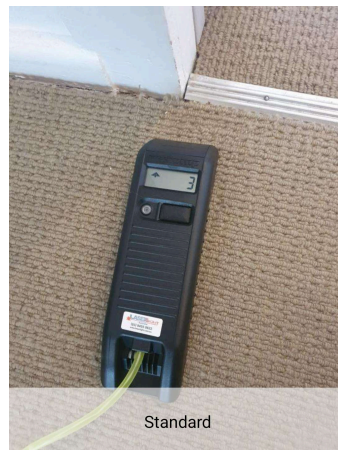
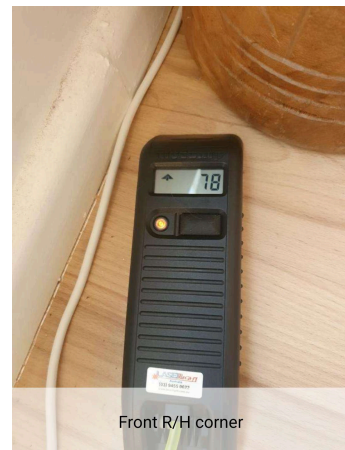
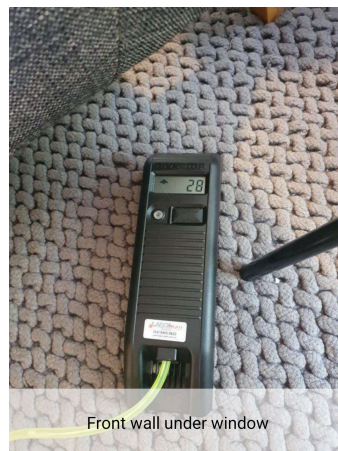
Flooring

Unevenness visible in floor which is generally caused due to by excessive movement/settlement. We recommend that a structural engineer is engaged to assess and rectify.

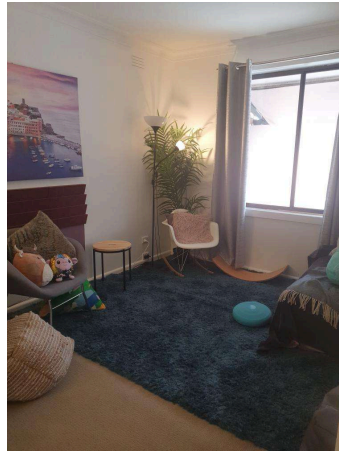
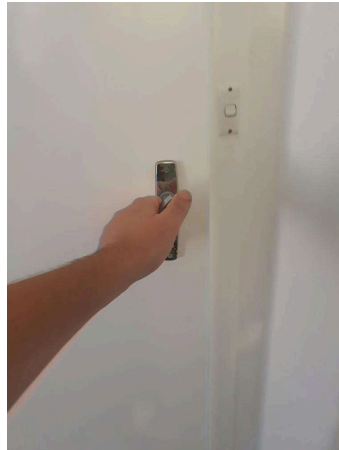
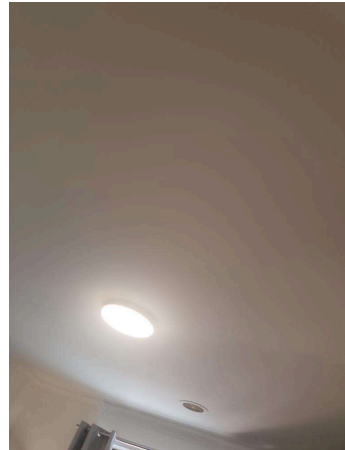
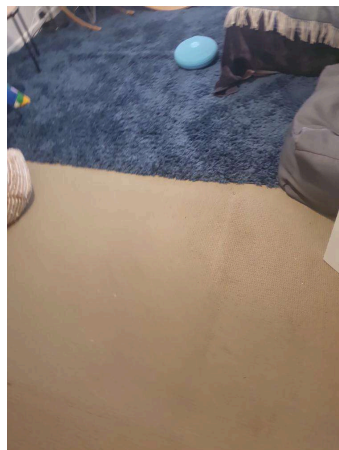
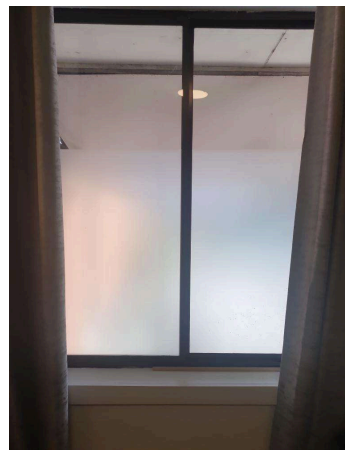
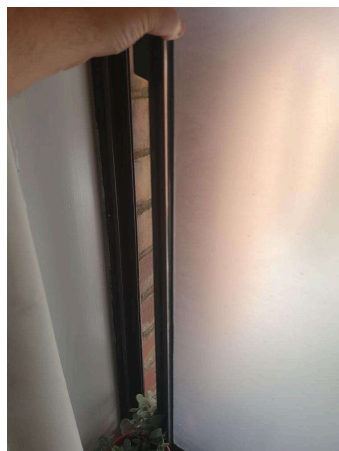
Flooring

Unevenness or unlevel sections visible in floor. Possibly due to poor workmanship or excessive movement/settlement. We recommend that a structural engineer is engaged to access and provide further recommendations.

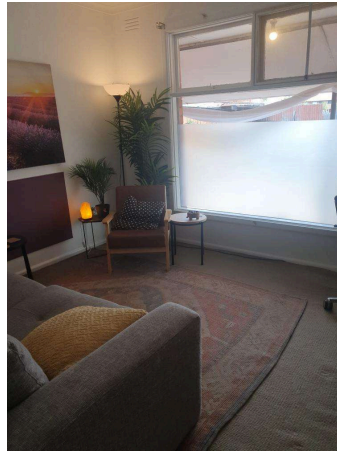
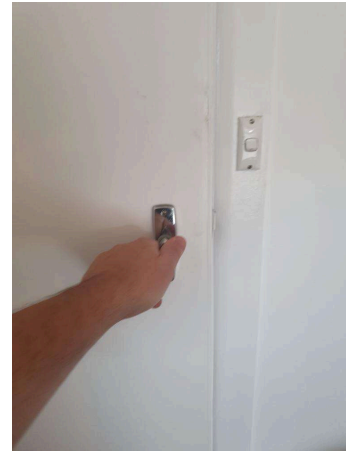
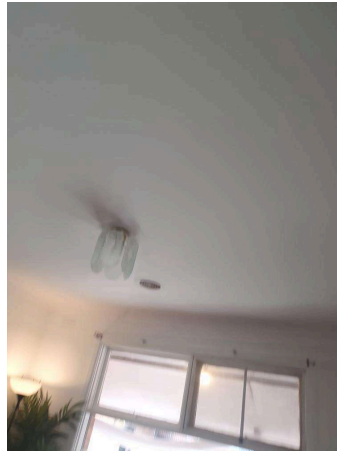
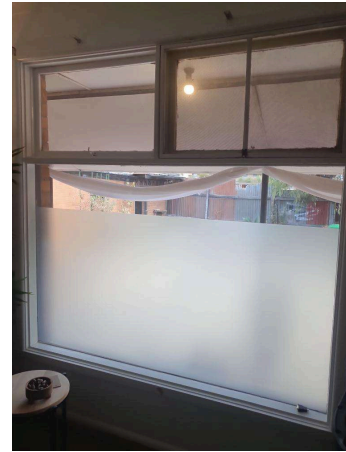
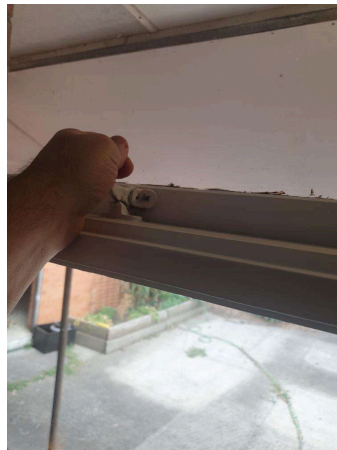
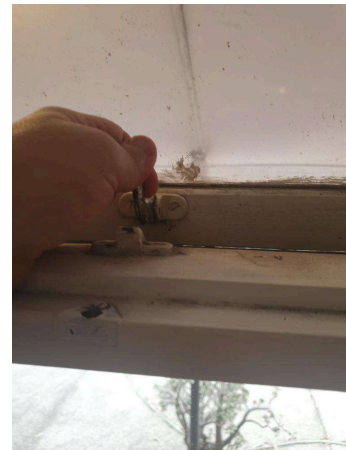
Flooring

Unevenness visible in floor. Possibly due to poor workmanship or excessive movement/settlement. A qualified carpenter should be engaged for advice and recommendations re levelling.

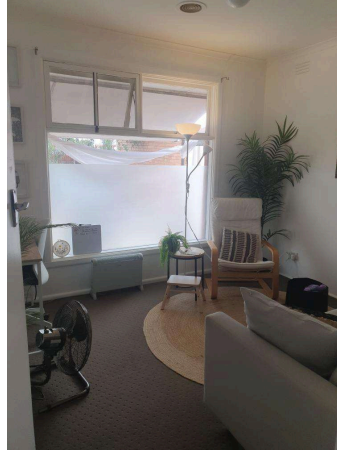
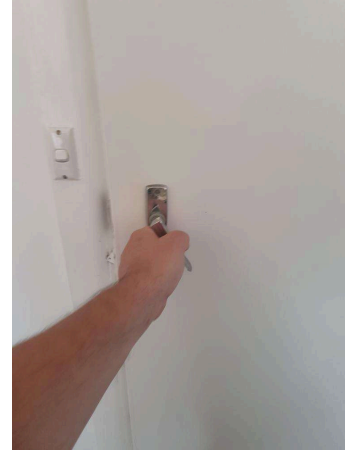
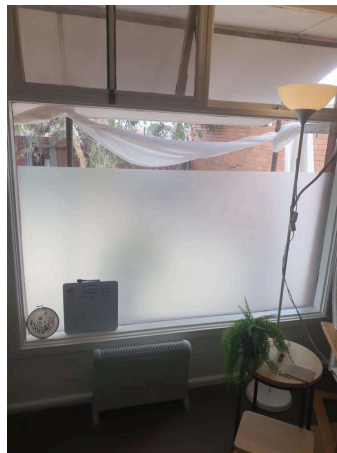
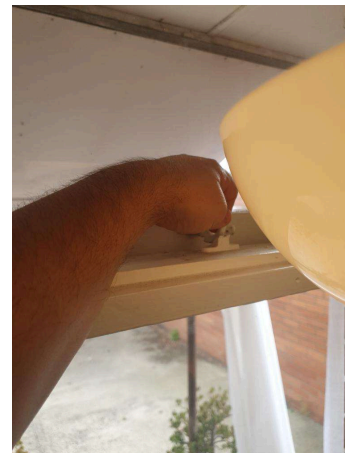
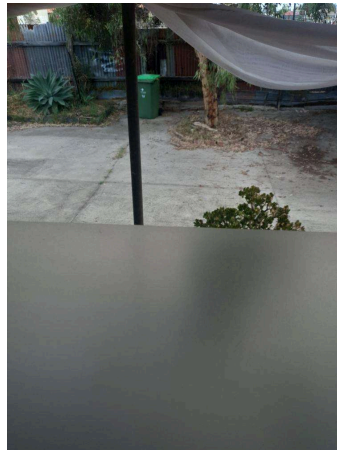
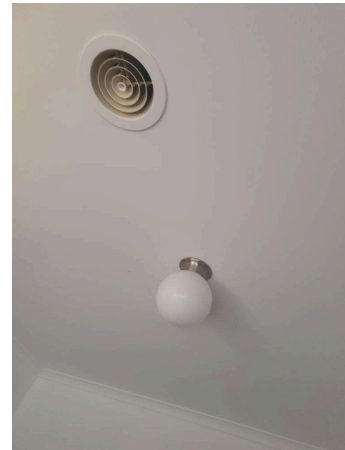
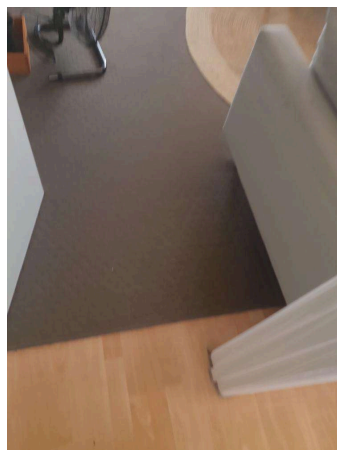
Flooring

Unevenness or unlevel sections visible in floor. Possibly due to poor workmanship or excessive movement/settlement. We recommend that a structural engineer is engaged to access and provide further recommendations.

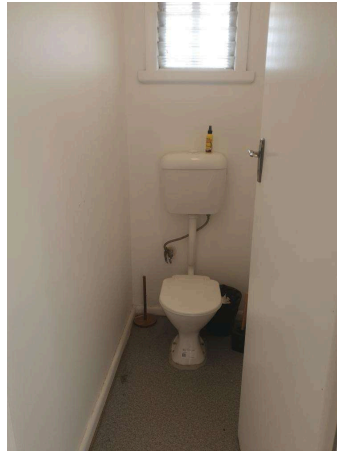
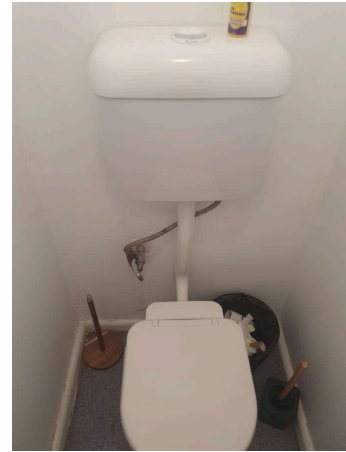
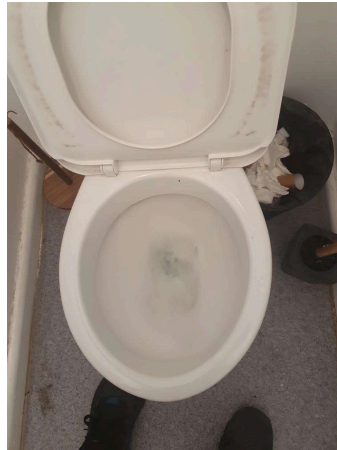
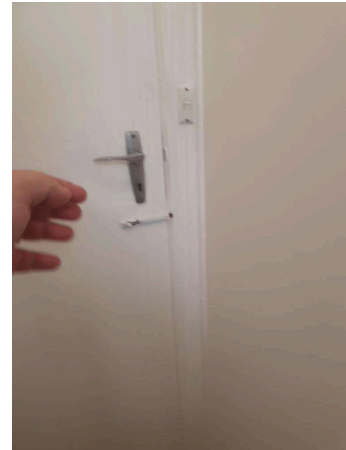
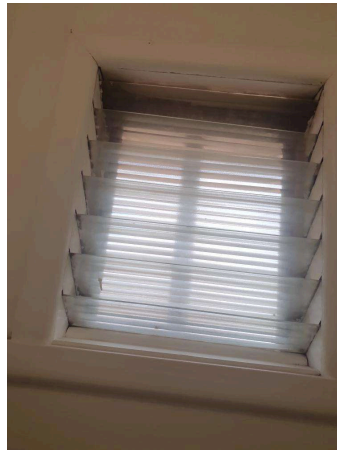
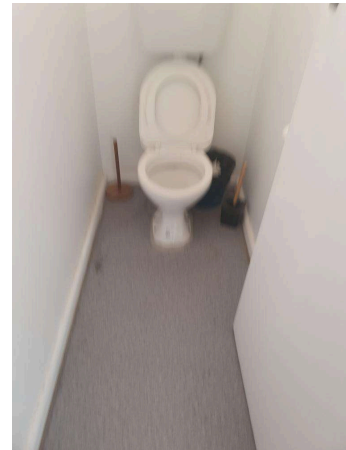
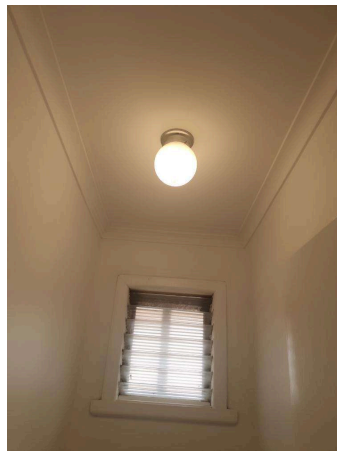
Unevenness or unlevel sections visible in floor. Possibly due to poor workmanship or excessive movement/settlement. We recommend that a structural engineer is engaged to access and provide further recommendations.

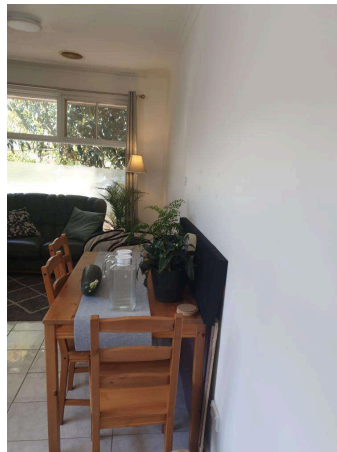
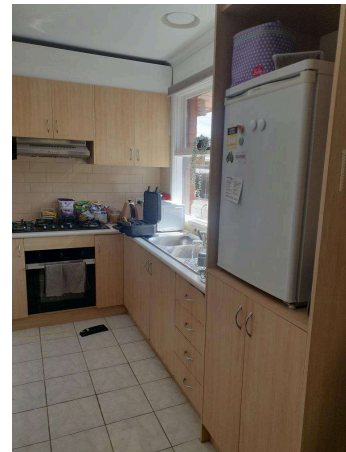
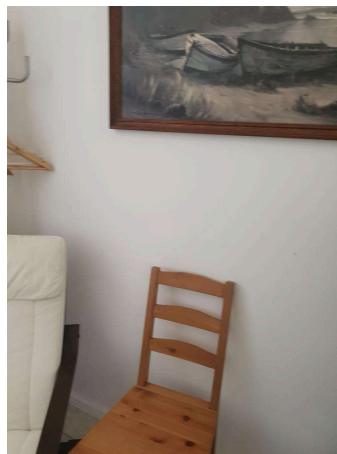
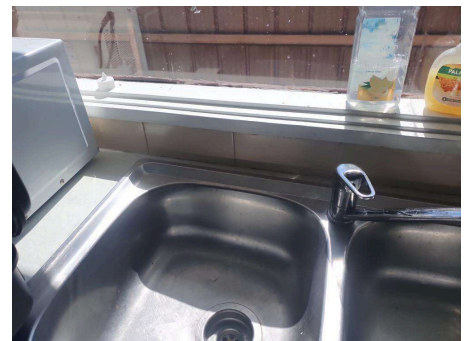
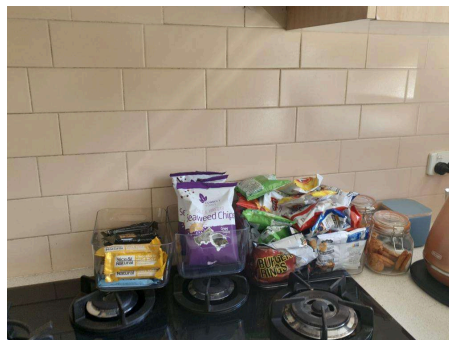
Binding window/s - This can relate to some differential settlement in the footings, frame movement, age and the like. It can also be seasonal where the windows may bind for some months and then open and close sufficiently. Recommendations: If binding is persistent, a qualified carpenter should be engaged for advice and recommendations.

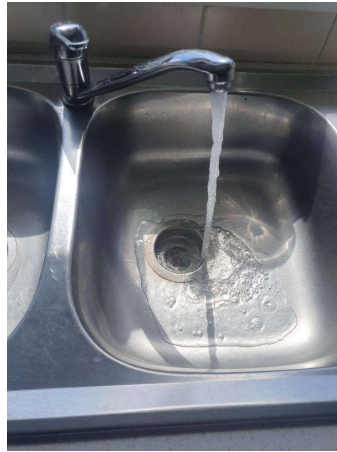
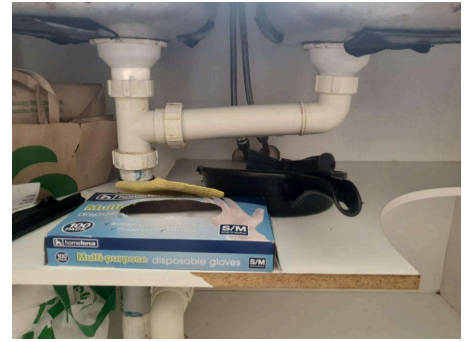
Water damage to cabinet observed. Replacement required. Contact a cabinet maker for repairs.

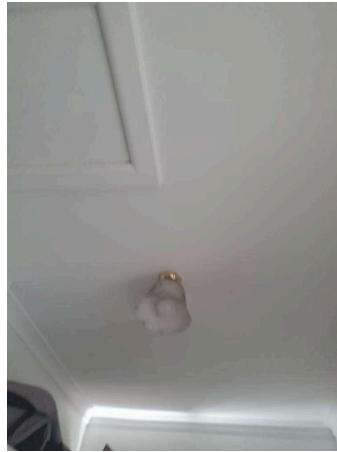
Ceiling paint flake/deterioration is evident. Recommendations: General maintenance / painting as required.

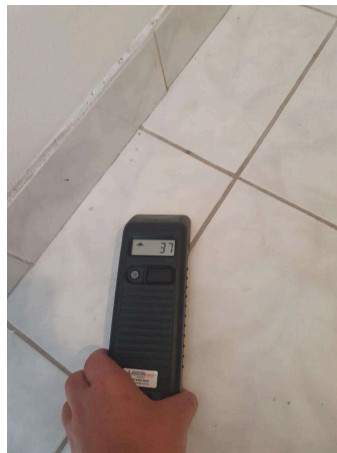
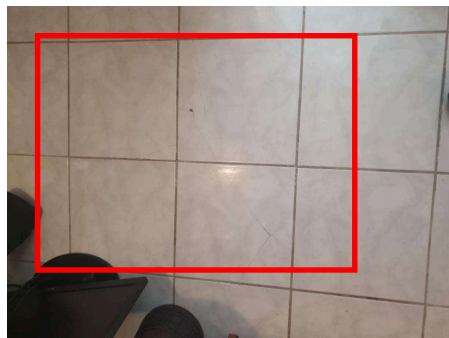
Floor

Cracked floor tiles - Recommendations: A qualified tiler should be engaged for advice and recommendations. This needs to be repaired at the earliest as this has the potential to lead to many related issues such as damp, water ingress to other areas. Unevenness visible in floor which is generally caused due to by excessive movement/settlement. We recommend that a structural engineer is engaged to assess and rectify.

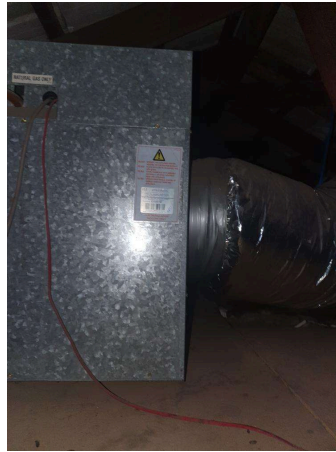
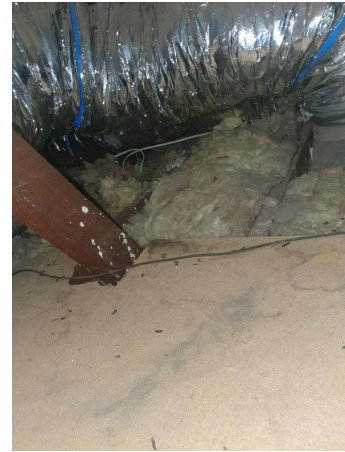
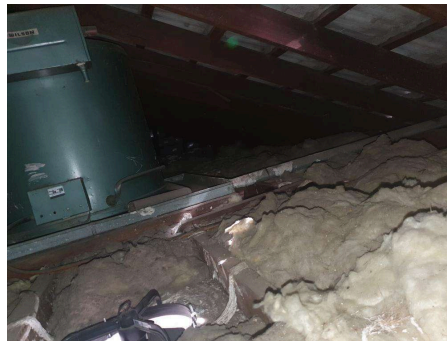
Hot water storage tank

There is heating and/or cooling system with ducting present in the roof space. This is preventing a full inspection from being undertaken. It is strongly recommended that full access be gained as it could be harbouring timber pest activity, damage or defects.

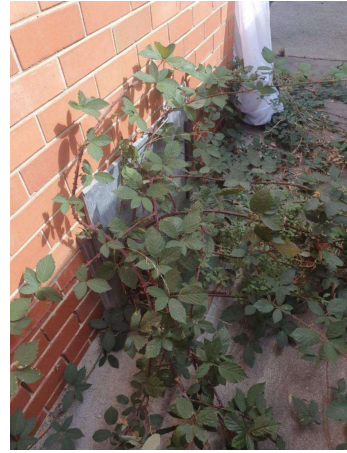
Restricted Areas

Inspection could not be conducted as there was no access to the subfloor. An invasive inspection of the area is required.
